BELZONA REBUILDS PAPER MILL CYCLONE

ID: 5393

Internal lining repair of a cyclone that feeds a hog fuel boiler.

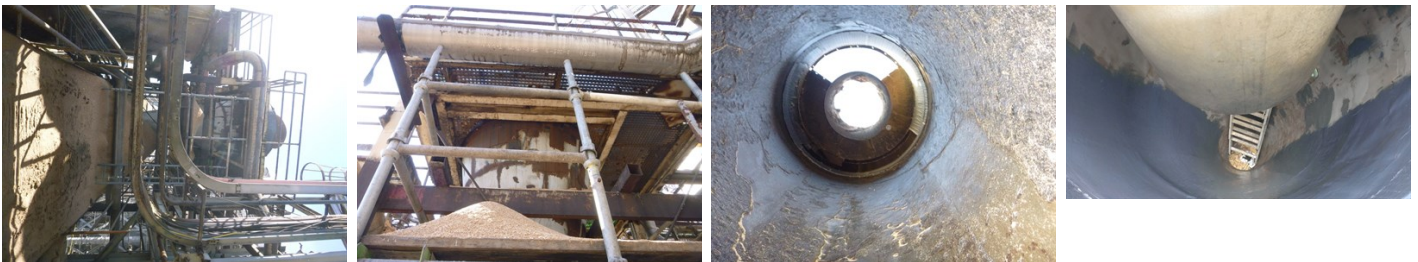
Photograph Descriptions

Erosion had progressed over the years to a point of significant material loss and holes emerging as hog fuel is metered through the cyclone.

- * Cyclone with lost material piled up around its base ,
- * Welded patches can be seen from outside ,
- * Pack rust and scale in the interior of the cyclone seen from below ,
- * Belzona 1311 applied as fillers and 1st coat of Belzona 1321 is applied ,

As usual, downtime was restricted and we had not been able to see interior surfaces prior to shutdown. Considerable pack rust was encountered, which required needle gunning prior to abrasive blasting. Belzona 1311 & 1321 were hand applied, as confined space offered no room for spray equipment use. Belzona 1311 was used to fill the voids and pits before a coat of Belzona 1321 was applied.
