# LEAK-FREE SKYLIGHTS WITH BELZONA!

Industry: Buildings & Structures  
Application: RPA-Roof Problem Areas  
Substrate: Steel

Customer Location: Missouri, USA  
Application Date: June, 2013

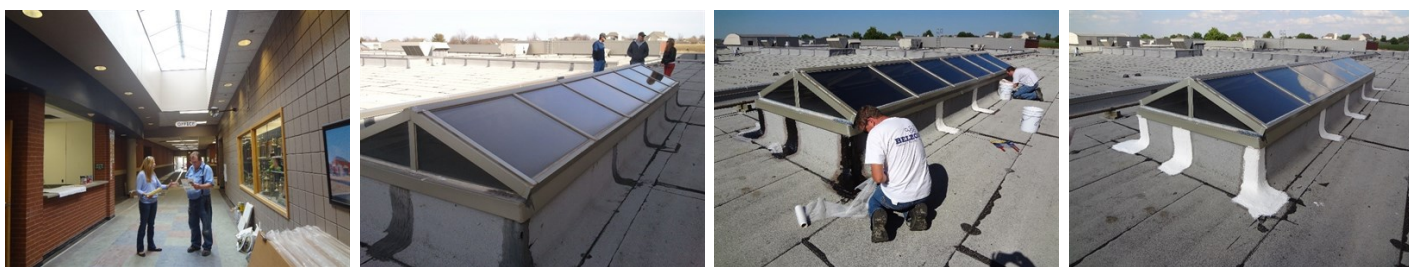
## Photograph Descriptions

The skylights in several different schools were leaking into the faculty and student areas below. Periodic temporary measures, such as caulking and mastics had been tried without solving this constant maintenance issue.

- \* 1. Consultant and School Official discussing the project in the main hallway directly below the leaking skylight. ,
- \* 2. Picture of a leaking skylight ,
- \* 3. Application of conditioner prior to meshing the seams ,
- \* 4. Completed repair with Belzona 3111 applied to the seams, flashing and glazing ,

Poorly engineered rooftop skylight(s) leaking into the main hallway and traditional roof repairs failed.

The application was carried out in accordance with Belzona Know-How System Leaflets RPA-3 & RPA-8 using Belzona 3111.
