LEAK-FREE SKYLIGHTS WITH BELZONA!

ID: 5396

Industry: *Buildings & Structures*
Application: *RPA-Roof Problem Areas*

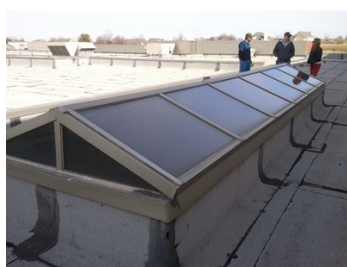
The skylights in several different schools were leaking into the faculty and student areas below. Periodic temporary measures, such as caulking and mastics had been tried without solving this constant maintenance issue.

- * 1. Consultant and School Official discussing the project in the main hallway directly below the leaking skylight. ,
- * 2. Picture of a leaking skylight ,
- * 3. Application of conditioner prior to meshing the seams ,
- * 4. Completed repair with Belzona 3111 applied to the seams, flashing and glazing ,
