BELZONA REPAIRS TIRE'S SIDEWALL

ID: 5406

Industry: Mining & Quarrying
Application: SHM-Solids Handling Machinery

Customer Location: Covington, VA, USA
Application Date: August 2014

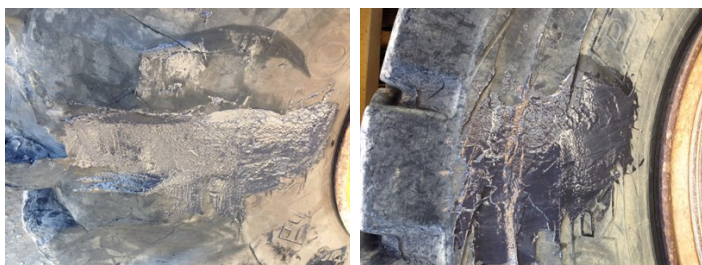
Photograph Descriptions

A tire of a front loader and a tire of a large dump truck had a cut in the sidewall rubber and a small chunk taken out of the sidewall, respectively. The tires would need to be replaced if there was no other alternative. They could remove the tire to be vulcanized, but that repair is costly and could take several days of downtime.

- * Completed application ,
- * Completed application ,

The surface area around the damage was prepared and roughened. The substrate was then conditioned with Belzona 2911. Once the conditioner dried, one coat of Belzona 2311 was applied around the damaged area. Then, Belzona 9341 was stippled before another coat of Belzona 2311 was applied.
