SLIPPERY FLOOR DRAIN GETS BELZONA GRIP!

ID: 5407

Application: FPA-Floor Problem Areas

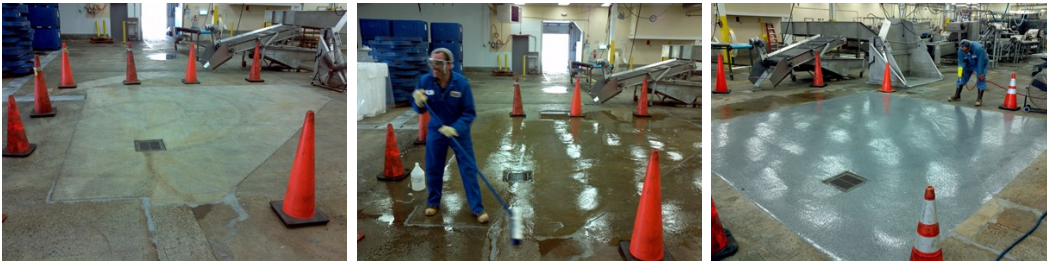
Photograph Descriptions

Concrete floor area around drain is very slippery with water & fish entrails. area sees both forklift and pedestrian traffic

- * Floor drain before the application ,
- * Thorough cleaning ,
- * Non-slip application of the floor drain is now complete ,

The application was carried out in accordance to Belzona Know-How System Leaflets FPA-3 and FPA-8. Concrete cleaned thoroughly and one heavy coat of Belzona 5811 applied to floor area. Belzona 9211 (Supergrip Aggregate) was then broadcast onto uncured material to create an aggressive non-slip surface.
