# SLIPPERY FLOOR DRAIN GETS BELZONA GRIP!

Application: FPA-Floor Problem Areas

Customer Location: Bellingham, WA, USA

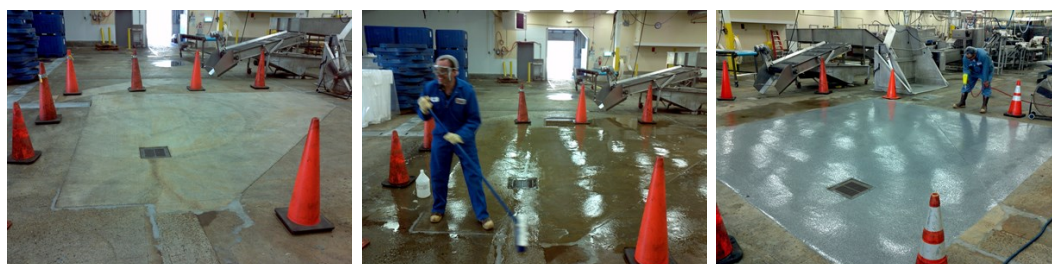
Concrete floor area around drain is very slippery with water & fish entrails. area sees both forklift and pedestrian traffic

- \* Floor drain before the application ,
- \* Thorough cleaning ,
- \* Non-slip application of the floor drain is now complete ,

The application was carried out in accordance to Belzona Know-How System Leaflets FPA-3 and FPA-8. Concrete cleaned thoroughly and one heavy coat of Belzona 5811 applied to floor area. Belzona 9211 (Supergrip Aggregate) was then broadcast onto uncured material to create an aggressive non-slip surface.
