# BELZONA REPAIRS AND PROTECTS LEAKING FLANGE ON CHILLER

ID: 5408

**Customer Location:** Lexington, VA, USA  
**Application Date:** July 2014

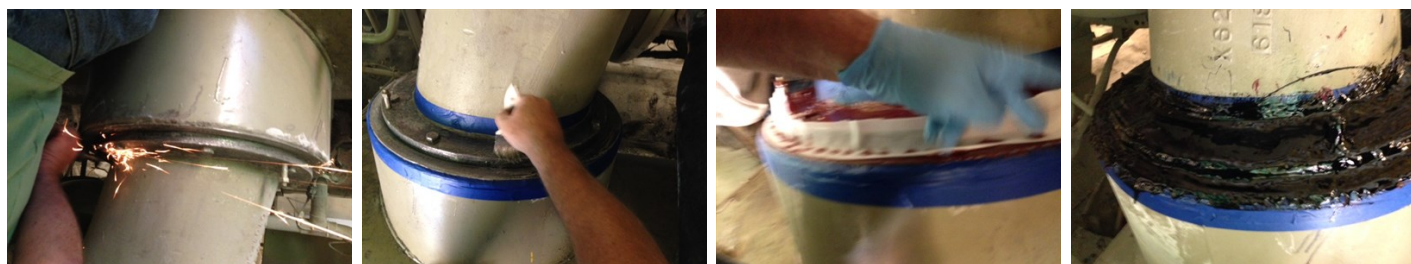
A leaking flange on a chiller resulted in the company trying several different products to stop the leak, but to no avail.

- \* Surface preparation to roughen the substrate ,
- \* Conditioning the substrate ,
- \* Applying reinforcing cloth over Belzona 2121 ,
- \* Completed application ,

The surface was prepared with a grinder to roughen the substrate. Then, the application area was taped off. Belzona 2911 was applied to condition the substrate and allowed to dry. We then used Belzona 2121 in red and stippled in reinforcing cloth over the seam and bolts. We went over and applied a second coat of Belzona 2121 in black. We let it sit overnight and it stopped the leak.
