Circulating Water Pump Repair

ID: 541

Customer Location: Power station, Egypt
Application Date: July 2004

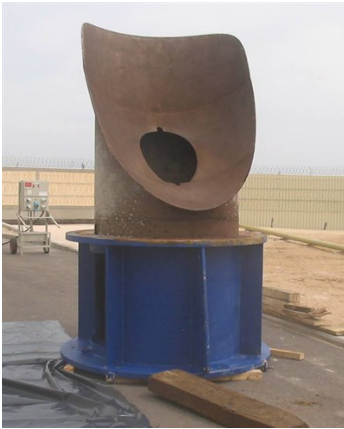
- * General view of the pump ,
- * The corroded discharge casing ,
- * Applying Belzona® 1311 to the prepared surface ,
- * Application complete ,

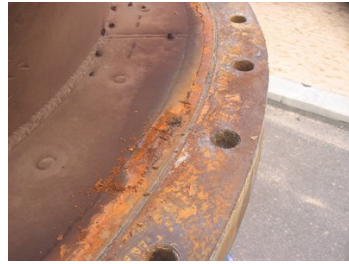
Galvanic corrosion between the cast iron of the discharge casing and the welded stainless steel sheet.

Belzona Polymers allow for a perfect repair, completed in only one day, keeping the power station on schedule. Welding was considered as an alternative method of repair but this would not prevent the same damage from occurring in the future. The customer, therefore, chose the most cost effective repair method.
