# Repair Corroded Cooling Tower Pipe with Belzona

**Customer Location:** Petrochemical Plant Southeast Texas  
**Application Date:** April 2013

3 sections of 30" x 10' Suction Pipe and 3 sections of 30" x 10' Discharge Pipe on Cooling Tower

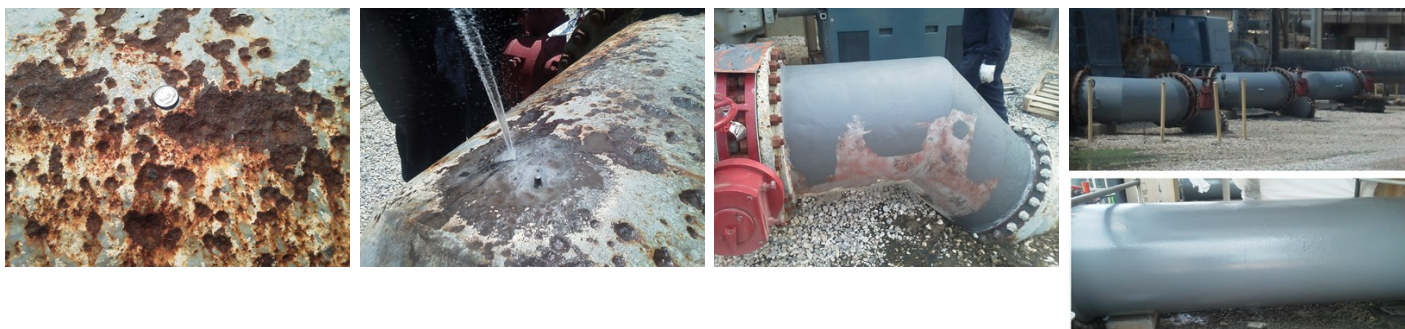
## Photograph Descriptions

Non-destructive testing (NDT) showed where heavy corrosion had caused major pitting resulting in thin walled pipe in many areas and through wall in one spot.

- \* Close-up of heavy corrosion ,
- \* Original leak and new through wall due to blast ,
- \* Belzona 1111 applied to fill the pits ,
- \* Finished project ,

Application carried out in accordance with Belzona Know How System Leaflet VPF-11. After proper surface preparation Belzona 1211 was used to fix the live leak. Belzona 1111 was then used to fill the pitting. Belzona 4151 with Belzona 9731 reinforcement tape were used to form a pipe wrap for strength. A final coat of Belzona 5111 was used for UV and environmental protection.
