BELZONA REPAIRS AND PROTECTS PUMP CASING

ID: 5415

Industry: General Industry
Application: CEP-Centrifugal Pumps
Substrate: Cast Iron
Products: * Belzona 1111 (Super Metal) ,
* Belzona 1341 (Supermetalglide) ,

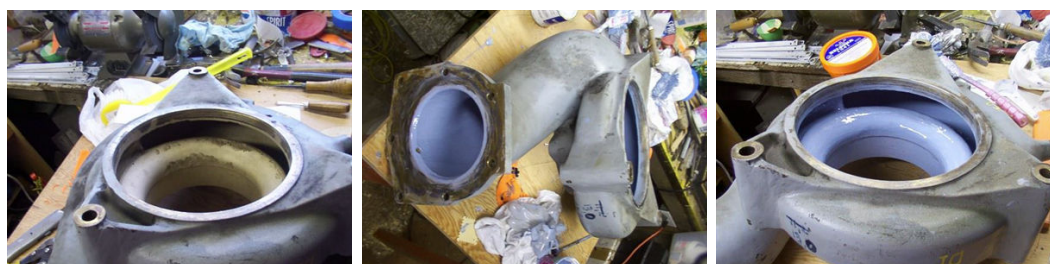
Photograph Descriptions

Pump casing was showing signs of degradation. This was from possible contamination during casting process.

- * View of casing showing damaged areas requiring rebuilding. ,
- * Application of 1st coat of Belzona 1341 in progress ,
- * Completed application. ,

The application was carried out in accordance with Belzona Know-How System Leaflet CEP-3, CEP-5.

A Belzona repair allowed the damaged areas to be quickly rebuilt and the casing protected from further bi-metallic erosion.
