# CORRODED PIPE REPAIRED WITH BELZONA!

ID: 5418

Customer Location: Petrochemical Plant, SE Texas, USA

Application: VPF-Valves, Pipes and Fittings

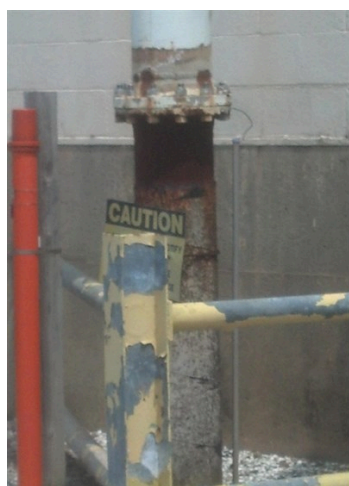
Poor protection on the flange caused corrosion to the pipe and flange.

- \* Before the application ,
- \* Sponge blasted and prepped with Belzona 5831 ,
- \* Belzona 1111 applied to all pits and gaps between nuts/bolts ,
- \* Belzona 5111 applied for corrosion and UV protection ,
