Belzona Repairs Broken Dielectrics

Industry: Power
Application: GSS-Gaskets, Seals and Shims
Substrate: Porcelain
Products: * Belzoana® 1111 (Super Metal) ,

Customer Location: Power station - Egypt
Application Date: February 2005

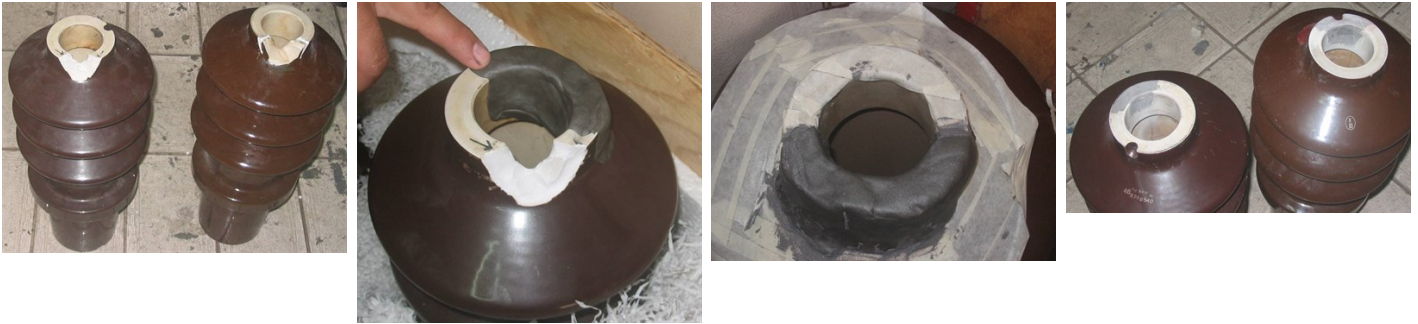
Photograph Descriptions

Dielectrics were broken at their edges causing oil infiltration from the connecting transformer.

- * The broken dielectrics ,
- * Making a former on the good edge using Belzona® 1111 ,
- * Reforming the broken edge ,
- * The two repaired dielectrics ,

Application was carried out in accordance with a modified version of Belzona Know-How System Leaflet GSS-1.

Belzona solved a serious problem in the dielectrics. Instead of buying new units, saving more than \$5,000. The dielectric strength of Belzona® 1111 made it a suitable choice for this application.
