# Belzona Repairs Broken Dielectrics

ID: 542

Customer Location: Power station - Egypt  
Application Date: February 2005

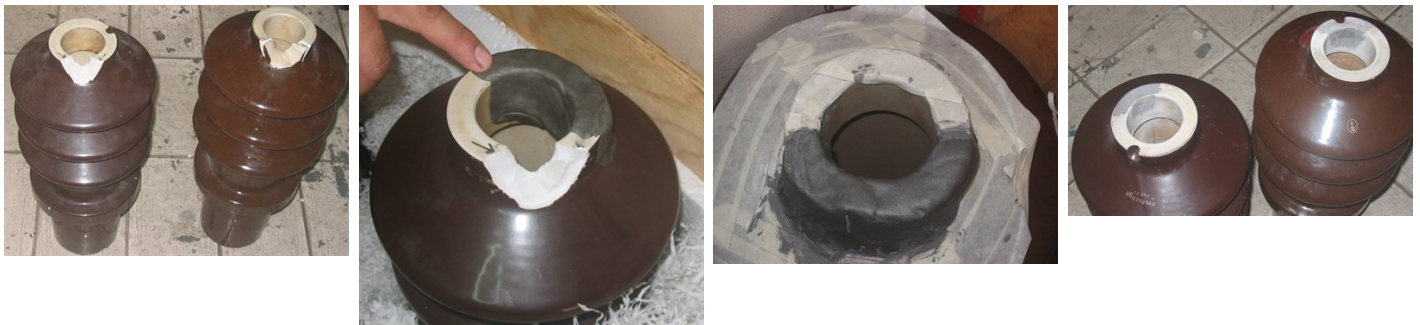
Dielectrics were broken at their edges causing oil infiltration from the connecting transformer.

- \* The broken dielectrics ,
- \* Making a former on the good edge using Belzona® 1111 ,
- \* Reforming the broken edge ,
- \* The two repaired dielectrics ,

Application was carried out in accordance with a modified version of Belzona Know-How System Leaflet GSS-1.

Belzona solved a serious problem in the dielectrics. Instead of buying new units, saving more than \$5,000. The dielectric strength of Belzona® 1111 made it a suitable choice for this application.
