Belzona Stops Clarifier Leak Externally

ID: 5422

Customer Location: Houston, Texas, USA
Application Date: June 2014

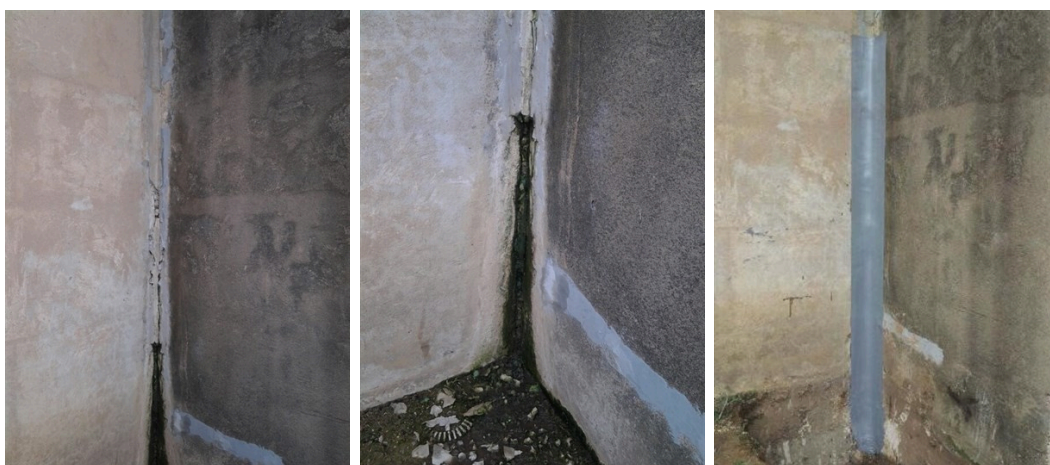
Photograph Descriptions

The leak was causing an environmental hazard as well as slippery walkways for pedestrians. The customer could not drain the unit. An external repair was needed to stop the leak.

- * The application area before repair ,
- * The application area before the area ,
- * The area after the application and leak free ,

Leak at clarifier wall

Application was carried out using a modified version of Belzona Know-How System Leaflet VPF-11. Belzona 1291 was used to stop the initial leak, then Belzona 1161 was applied with Belzona 9341 reinforcement cloth over the entire area.
