BELZONA REPAIRS A TANK ROOF AND SAVES THE PLANT FROM SHUTDOWN

Industry: Chemical & Petrochemical
Application: TCC-Tanks and Chemical Containment Areas

Customer Location: South Louisiana, USA

Application Date: June 2014

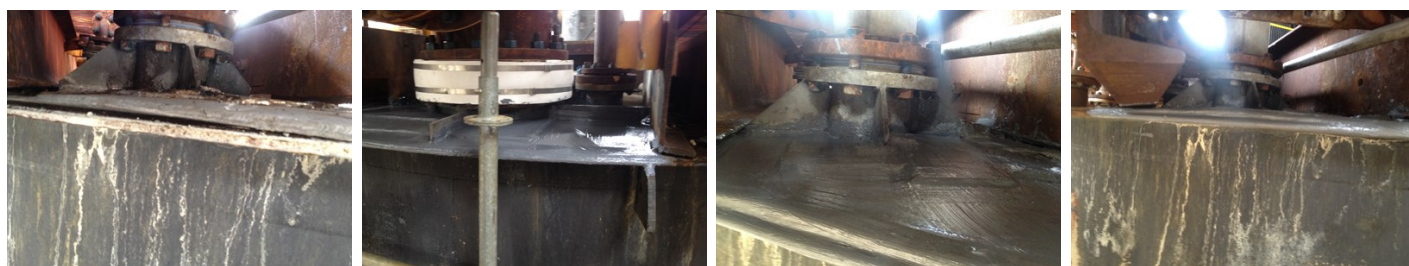
Photograph Descriptions

- * Separation of top from tank ,
- * After coating with Belzona 1161 and Belzona 4301 ,
- * Sealing of holes and cracks ,
- * Tank top sealed with Belzona products ,

Holes and corrosion on top of sulfuric acid tank and separated top of tank.

Vapors were escaping from the tank due to tank top separating. Vapors were also thinning metal in about a 60 sq. ft. area. Customer had welded plates over holes but needed a coating with resistance to sulfuric acid vapors.

The application was carried out in accordance with Belzona Know-How System Leaflets TCC-1 & TCC-5.
