BELZONA REMEDIATES A DOCK AT A SUGAR REFINERY

Industry: Sugar
Application: FPA-Floor Problem Areas
Substrate: Concrete
Products: * Belzona 4111 (Magma Quartz) ,
* Belzona 4911 (Magma TX Conditioner) ,
* Belzona 9111 (Cleaner/Degreaser) ,

Customer Location: South Louisiana, USA
Application Date: August and September 2014

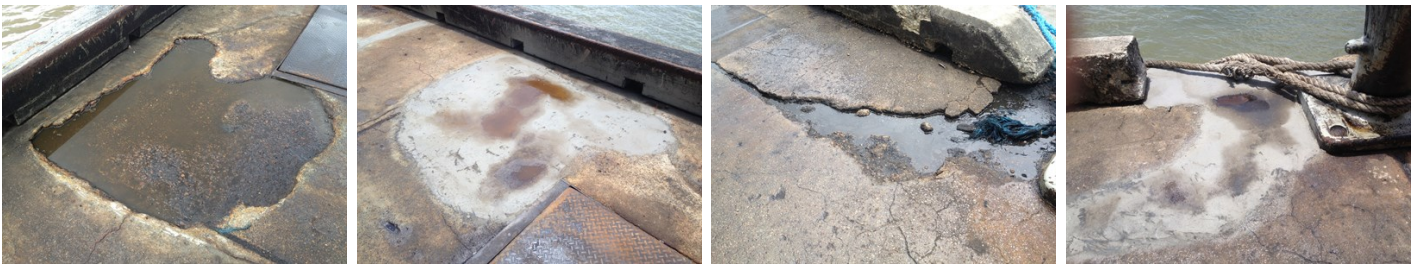
Photograph Descriptions

Abuse from the metal tractor wheels combined with sugar and water causing concrete to be eroded. The dock was becoming unsafe for equipment and pedestrians.

- * 1. Before the application in the first area ,
- * 2. Application complete in the first area ,
- * 3. Before the application in the second area ,
- * 4. Application complete in the second area ,

Application was carried out in accordance with Belzona Know-How System Leaflet FPA-1.

Safety issues are being resolved. Belzona product is the first polymer repair product the Customer has used that didn't fail in the first few days of operation.
