BELZONA STOPS THE LEAK ON FIREWATER SYSTEM

ID: 5430

Customer Location: Tank Terminal, South Louisiana, USA
Application Date: September 2014

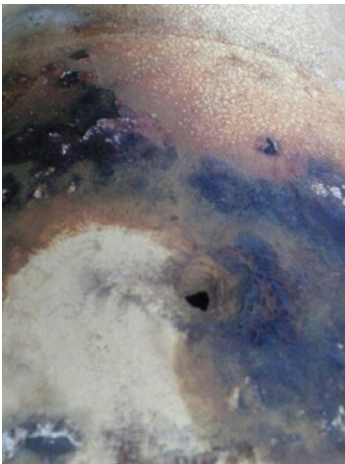
The piping was old and had not been taken care of. Many clamps on the lines, but leaks were starting to appear under the clamps. There were other places in the line where actual holes had appeared from corrosion.

- * 1. One of the holes in the pipe ,
- * 2. Water flowing from the pipe ,
- * 3. Area of the pipe that was leaking ,
- * 4. Application completed ,

Application was carried out in accordance with a modified Belzona Know-How System Leaflet VPF-11.
