BELZONA REPAIRS A DOCK HOSE BEFORE INSPECTION

ID: 5431

Industry: *Marine*
Application: *SOS-Ships and Offshore Structures*

Customer Location: *Terminal Dock, Louisiana, USA*
Application Date: *July 2013*

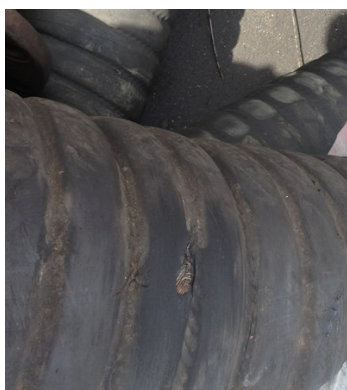
Over the years as the dock hose had been drug around the deck and over shipside, the hose had been cut and gouged.

- * 1. Area being prepared for repair. ,
- * 2. Area after Belzona 2911 applied. ,
- * 3. Belzona 2311 applied. ,
- * 4. Finished repair before tape removed. ,

After proper surface preparation, the application was carried out in accordance with a modified version of Belzona Know-How System Leaflet SOS-12.
