BELZONA REPAIRS A DOCK HOSE BEFORE INSPECTION

ID: 5431

Customer Location: *Terminal Dock, Louisiana, USA*
Application Date: *July 2013*

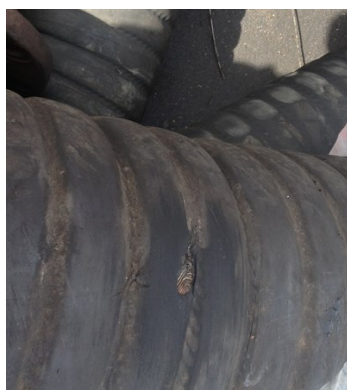
Over the years as the dock hose had been drug around the deck and over shipside, the hose had been cut and gouged.

- * 1. Area being prepared for repair. ,
- * 2. Area after Belzona 2911 applied. ,
- * 3. Belzona 2311 applied. ,
- * 4. Finished repair before tape removed. ,

After proper surface preparation, the application was carried out in accordance with a modified version of Belzona Know-How System Leaflet SOS-12.
