# BELZONA REBUILDS AND PROTECTS FERRY RUDDER HORNS

ID: 5441

Industry: *Marine*  
Application: *SOS-Ships and Offshore Structures*

Customer Location: *BC, Canada*  
Application Date: *December 2004*

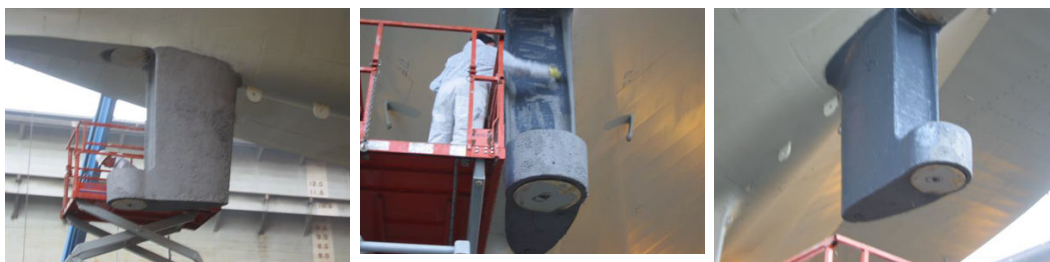
## Photograph Descriptions

*The rudder horns are subject to both erosion and cavitation damage.*

\* 1. Rudder horn after grit blasting to a near white metal finish 2. Application of 1st coat in progress 3. Completed application ,

Application carried out in accordance with Belzona Know-How System Leaflet SOS-1/2

Rebuilding eroded areas with Belzona rebuilding compounds is both quick and effective saving many hours of dry docking time. The conventional way would be welding.
