# BELZONA REBUILDS AND PROTECTS RUDDERS

ID: 5442

Application: *SOS-Ships and Offshore Structures*

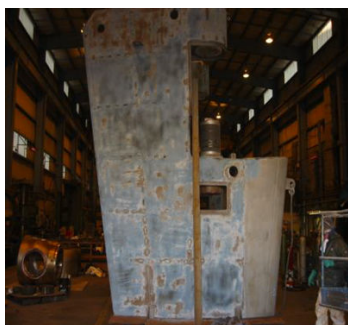
*Vessel rudders are subjected to continuous erosion and cavitation attack.*

- \* 1. Rudders in set up after blasting ready for application. 2. Rudders after application of 2 coats of Belzona 1341 Supermetalgilde. 3. Condition of rudders / rudder horn after 12 years of service with Belzona coating. ,

Application carried out in accordance with Belzona Know-How System Leaflet SOS-1/2
