BELZONA USED FOR EMERGENCY BOW THRUSTER REPAIR

ID: 5445

Industry: *Marine*
Application: *SOS-Ships and Offshore Structures*

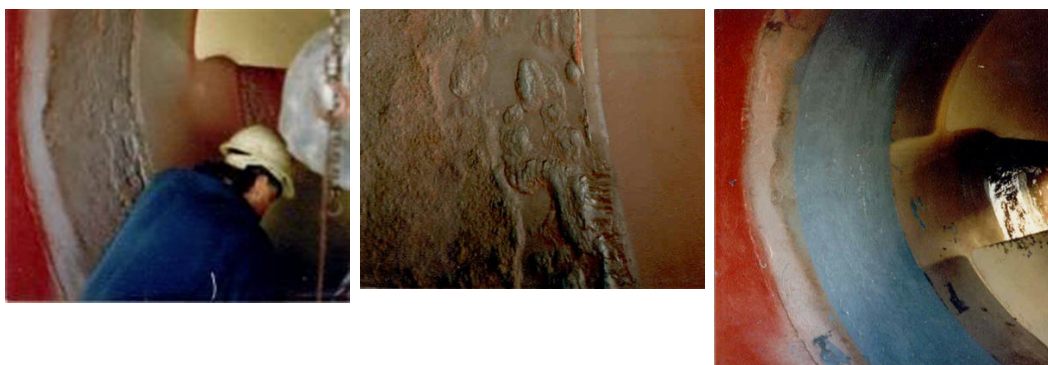
Photograph Descriptions

Bow thruster insert was suffering from major corrosion-erosion problems.

- * Preparation of bow thruster underway with a check on actual metal thickness. ,
- * Close up showing extent of problem. ,
- * Completed application. ,

The application was carried out in accordance with Belzona Know-How System Leaflet SOS-1.

The use of Belzona ensured that the repair could be carried out effectively, quickly and eliminating welding. This also reduced dry dock time as the vessel was in for an inspection only when the bow thruster became an additional issue of concern.
