# BELZONA USED FOR EMERGENCY BOW THRUSTER REPAIR

ID: 5445

Industry: *Marine*  
Application: *SOS-Ships and Offshore Structures*

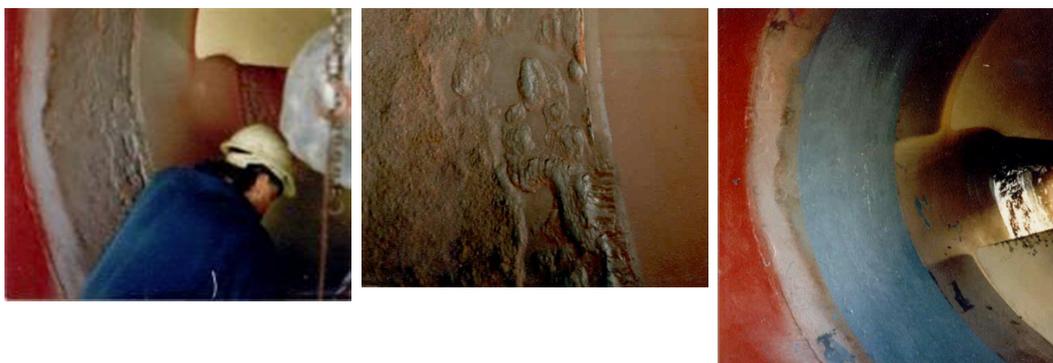
## Photograph Descriptions

*Bow thruster insert was suffering from major corrosion-erosion problems.*

- \* Preparation of bow thruster underway with a check on actual metal thickness. ,
- \* Close up showing extent of problem. ,
- \* Completed application. ,

The application was carried out in accordance with Belzona Know-How System Leaflet SOS-1.

The use of Belzona ensured that the repair could be carried out effectively, quickly and eliminating welding. This also reduced dry dock time as the vessel was in for an inspection only when the bow thruster became an additional issue of concern.
