# BELZONA 1341 SUPERMETALGLIDE PROTECTS RUDDERS

ID: 5449

Industry: Marine

Application: SOS-Ships and Offshore Structures

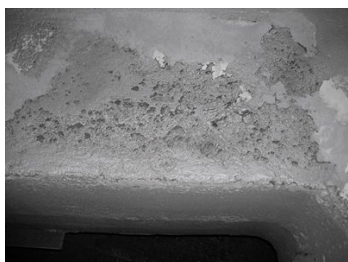
*Rudders were showing sever metal loss in areas where cavitation attack prevalent .*

\* 1. View of one of the many badly cavitated areas on the two rudders 2. Rebuilding of eroded areas in progress 3. Application of 1st coat of Belzona 1341 in progress 4. Application of 2nd coat of Belzona 1341 completed ,

The use of Belzona for these types of repairs eliminates the need to weld with all its associated problems. The rebuild process also reduces the time required to complete a repair of this kind.
