# Belzona Roller Repair

Customer Location: Cement manufacturer in Egypt  
Application Date: June 2003

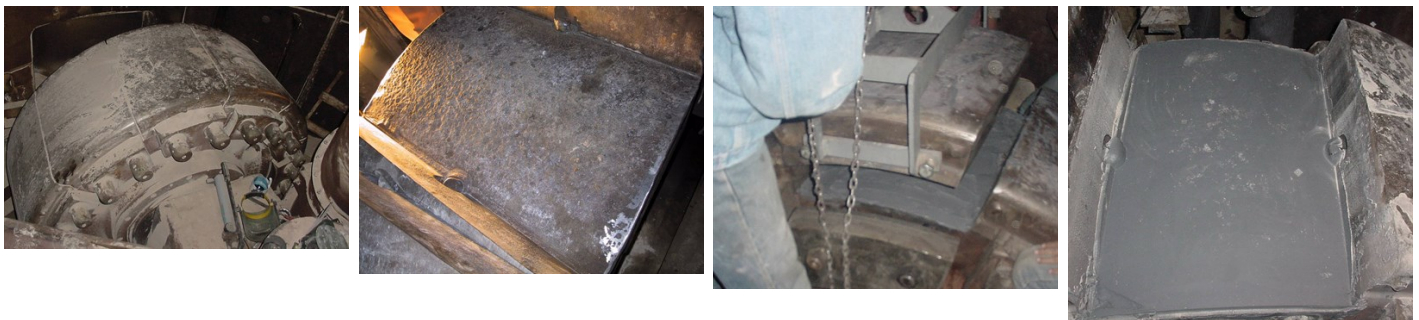
## Photograph Descriptions

*Excessive wear under the steel tile of the roller due to failure of steel tile during operation.*

- \* General view of the roller ,
- \* The wear under the steel tile of the roller ,
- \* Forming the worn out area using the steel tile ,
- \* Application complete ,

Application was carried out in accordance with Belzona Know-How System Leaflet TCC-13.

Belzona was used to perfectly repair the roller in place, returning the worn out surface to its original dimensions with minimum down time and cost. Alternatives would be hard to apply due to the huge size of the roller and would have required significantly more money and time. This application is still in service and has become a standard repair procedure on similar equipment.
