BELZONA REPAIRS CONCRETE RAMP

ID: 5457

Industry: *Buildings & Structures*
Application: *FPA-Floor Problem Areas*
Substrate: *Concrete*
Products: ** Belzona 4111 (Magma Quartz) ,*

Customer Location: *Bellingham, WA, USA*
Application Date: *September 2014*

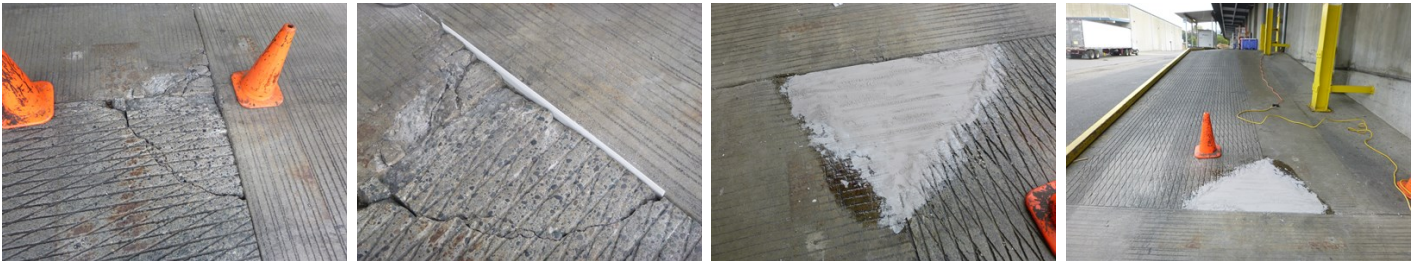
Photograph Descriptions

The foundation under the loading ramp had been undermined causing one concrete panel to crack which made a bump in the road for forklifts, which would then lose loads when hitting this joint.

- * Area on forklift ramp for repair ,
- * Teflon spacer fit into joint to separate adjacent panels ,
- * Conditioner (seen around edge) and 4111 applied to repair area ,
- * The ramp repaired from a distance ,

The application was carried in accordance with Belzona Know-How System Leaflet FPA-1. The substrate was thoroughly cleaned and loose material removed. A Teflon spacer was placed into the joint to separate adjacent panels thus avoiding a repeat of cracking that had occurred. The Conditioner was brush applied and Belzona 4111 was hand applied.
