# Belzona Repairs Ships Generator Shaft

ID: 546

Industry: *Marine*  
Application: *MPT-Mechanical Power Transmission*

Customer Location: *Shipping company - Egypt*  
Application Date: *February 2005*

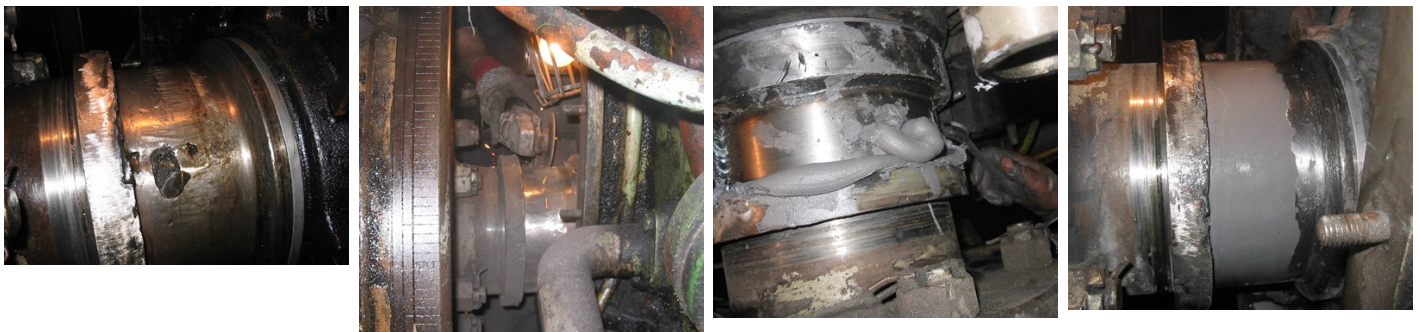
## Photograph Descriptions

*Worn generator drive shaft located in a narrow, confined place.*

- \* View of the generator shaft prior to the repair. ,
- \* Surface preparation in progress. ,
- \* Form was applied. Then excess material was removed. ,
- \* Completed shaft repair. ,

Application was carried out in accordance with Belzona® Know-How System Leaflet MPT-2.

Belzona successfully repaired the shaft in a cramped environment without disassembling the shaft. This allowed the ship to keep schedule without delay.
