Belzona Repairs Ships Generator Shaft

ID: 546

Industry: *Marine*
Application: *MPT-Mechanical Power Transmission*

Customer Location: *Shipping company - Egypt*
Application Date: *February 2005*

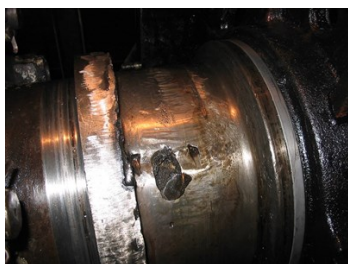
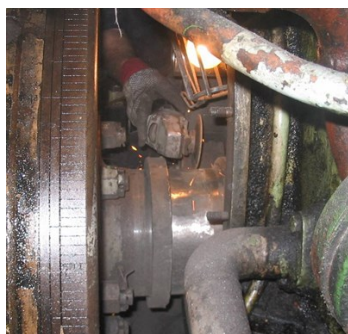
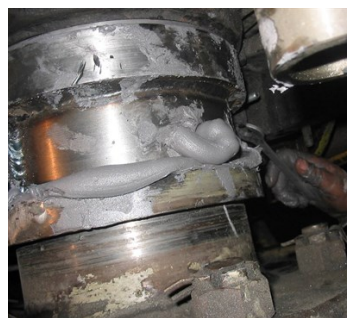
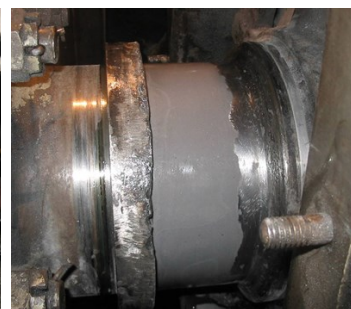
Photograph Descriptions

Worn generator drive shaft located in a narrow, confined place.

- * View of the generator shaft prior to the repair. ,
- * Surface preparation in progress. ,
- * Form was applied. Then excess material was removed. ,
- * Completed shaft repair. ,

Application was carried out in accordance with Belzona® Know-How System Leaflet MPT-2.

Belzona successfully repaired the shaft in a cramped environment without disassembling the shaft. This allowed the ship to keep schedule without delay.
