ROOF PROTECTION TO RESERVOIR VALVE TOWER

ID: 5461

Industry: *Commercial Facilities* Customer Location: *Blackburn, UK*
Application: *RPA-Roof Problem Areas* Application Date: *June 2014*
Substrate: *Concrete*
Products: ** Belzona 4131 (Magma Screed) Belzona 3131 (WG Membrane),*

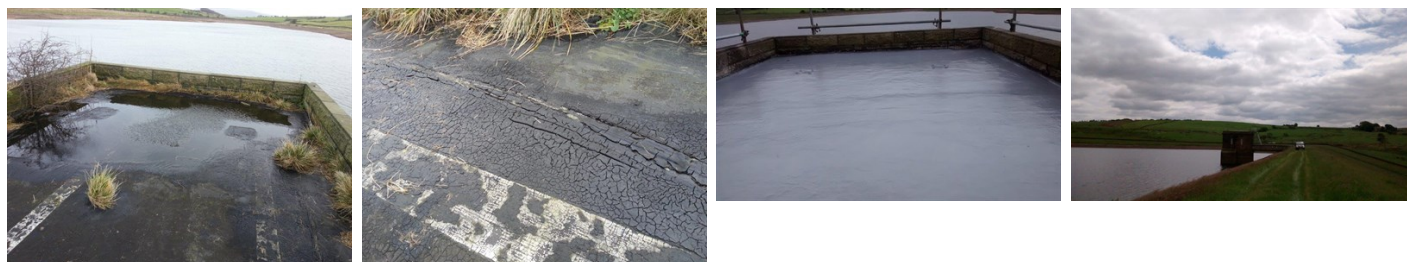
Photograph Descriptions

Damage to asphalt coated roof causing water ingress resulting in spalling concrete underneath. There was also severe plant growth.

* 1. Standing water causing damage 2. Damage to substrate 3. Completed Repair 4. Isolated Location ,

Dilapidated asphalt coated concrete roof

The application was carried out in accordance with FPA-1, RPA-1 and RPA-6. All of the damaged asphalt and plant growth was removed and the damaged concrete was rebuilt with Belzona 4131 . Belzona 3131 was subsequently applied to the entire area to prevent further water ingress.
