ROOF PROTECTION TO RESERVOIR VALVE TOWER

ID: 5461

Customer Location: Blackburn, UK
Application Date: June 2014

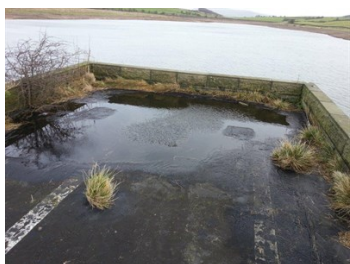
Damage to asphalt coated roof causing water ingress resulting in spalling concrete underneath. There was also severe plant growth.

* 1. Standing water causing damage 2. Damage to substrate 3. Completed Repair 4. Isolated Location ,

The application was carried out in accordance with FPA-1, RPA-1 and RPA-6. All of the damaged asphalt and plant growth was removed and the damaged concrete was rebuilt with Belzona 4131 . Belzona 3131 was subsequently applied to the entire area to prevent further water ingress.
