BELZONA RENEWS HOG ELBOW

ID: 5464

Industry: *General Industry*
Application: *SHM-Solids Handling Machinery*

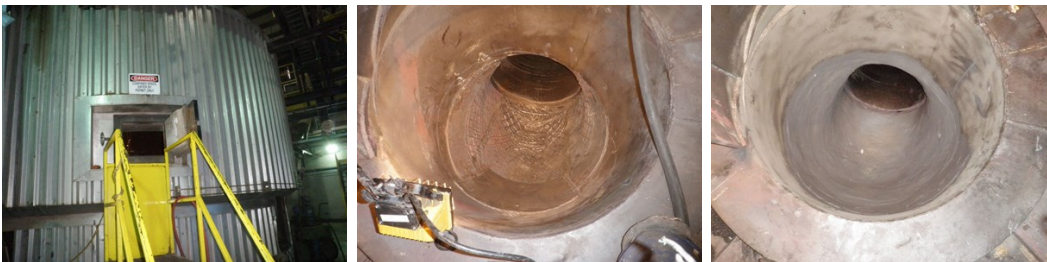
Photograph Descriptions

The elbow wears where at one point it was criss-crossed with an AR weld. Unfortunately, the fuel feed would hang up on the AR weld pattern, causing the auger to work much harder.

- * The burn chamber exterior and access door. ,
- * The interior of the elbow from above. The Belzona product from the original application 10 years ago is still visible. ,
- * Completed application. ,

The application was carried out in accordance with Belzona Know-How System Leaflet SHM-8. The surface was grit blasted; Belzona 1812 was applied by applicator and it was then overcoated with Belzona 1321 for smoothness.

This elbow is one of three originally surfaced in 2004 with Belzona 1812, which was found to not only protect the elbow, but significantly reduce auger torque as well. 10 years later this elbow needed a new coating and Belzona was asked to renew the application.
