# BELZONA SOLVES LEAKING PROBLEM ON GAS PIPE

ID: 5466

Customer Location: Gas Distribution Company, Stuttgart,  
Germany

Application: GSS-Gaskets, Seals and Shims

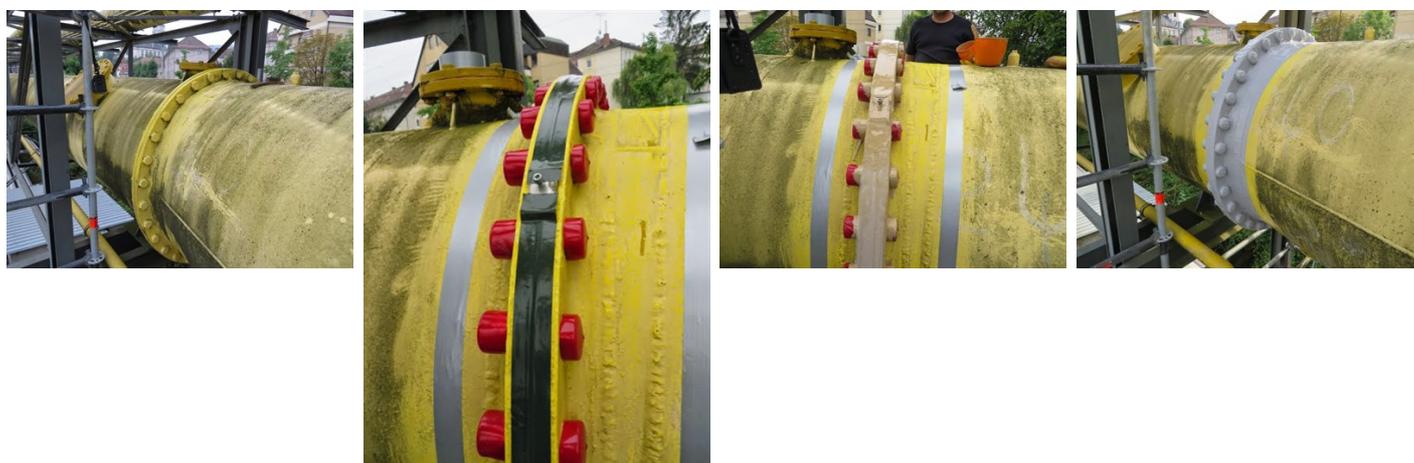
Due to aged and leaky seals between the flange face, gas was leaking on five flanges of a natural gas pipe coming from a gasometer. Pressure is 0.5 bar.

- \* Flange prepared for the application ,
- \* Bolted caps, sealed gap and embedded screw ,
- \* During application of the first coat of Belzona 3411 ,
- \* After application of the second coat of Belzona 3411 ,

The substrate was manually prepared as described in the IFU and the application was carried out in accordance with Belzona Know-How System Leaflet GSS-11. The embedded screw helped for releasing the gas pressure until the application was cured. Belzona 8411 was not used because the customer does not require the protection to be reopened or to be inspected in the future.
