Belzona Floating Roof Repair

ID: 547

Customer Location: Oil refinery, Egypt
Application Date: December 2004

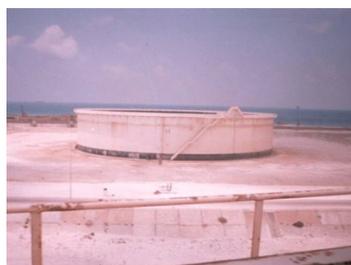
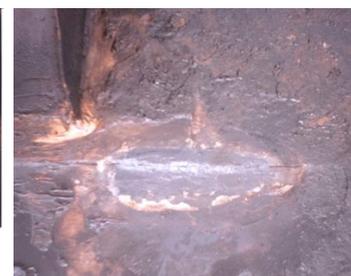
Crude oil leakage through welding seams in the tanks floating roof.

- * General view of the crude oil tank ,
- * The contaminated area of the floating roof ,
- * Cleaning the surface ,
- * Leakage stopped (shown) and in other locations ,

Belzona® 1291 was used to stop the active leak quickly. The flexibility and quick cure of Belzona® 2311 makes it the ideal choice for these types of applications. The Belzona will not crack from the movement of the roof up and down.
