# Belzona Floating Roof Repair

**Customer Location:** Oil refinery, Egypt  
**Application Date:** December 2004

Crude oil leakage through welding seams in the tanks floating roof.

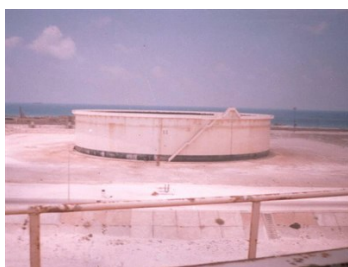
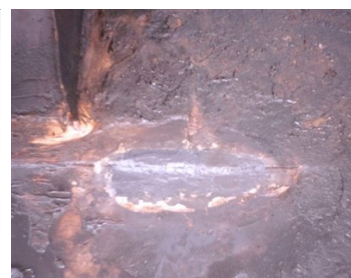
- \* General view of the crude oil tank ,
- \* The contaminated area of the floating roof ,
- \* Cleaning the surface ,
- \* Leakage stopped (shown) and in other locations ,

Belzona® 1291 was used to stop the active leak quickly. The flexibility and quick cure of Belzona® 2311 makes it the ideal choice for these types of applications. The Belzona will not crack from the movement of the roof up and down.
