# BELZONA REPAIRS AND PROTECTS BULB GENERATOR SET

Customer Location: Hydropower Plant - France  
Application Date: March 2001

Bulb generator set.

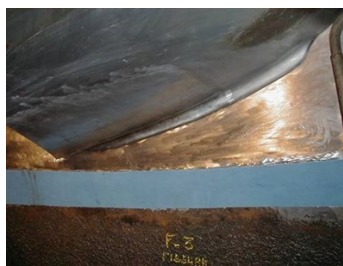
Important infiltration and corrosion between stainless steel jacket and turbine housing.

- \* General view of the housing ,
- \* Junction between steel and stainless steel ,
- \* Completed repair and protection ,

The damaged junction was repaired with Belzona 1111 and protected with Belzona 1341. The application was completed by the customer.
