# BELZONA REPAIRS AND PROTECTS BULB GENERATOR SET

ID: 5472

Customer Location: Hydropower Plant - France  
Application Date: March 2001

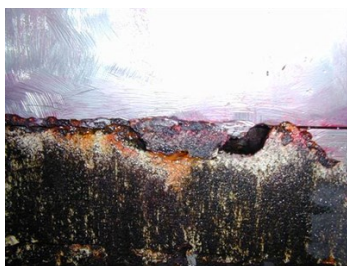
Important infiltration and corrosion between stainless steel jacket and turbine housing.

- \* General view of the housing ,
- \* Junction between steel and stainless steel ,
- \* Completed repair and protection ,

The damaged junction was repaired with Belzona 1111 and protected with Belzona 1341. The application was completed by the customer.
