BELZONA PROTECTS CYCLONE

ID: 5473

Industry: *General Industry*
Application: *TCC-Tanks and Chemical Containment Areas*

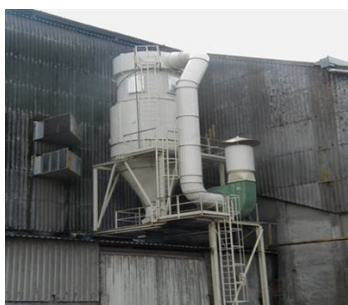
Abrasion inside the cyclone and through-wall damages caused by corncobs.

- * Cyclone to be repaired ,
- * Presence of holes due to abrasion ,
- * Repair with Belzona 1311 and protection with Belzona 1321 ,
