# BELZONA PROTECTS BUFFER STONE WITH INTERNAL COATING

ID: 5474

Customer Location: Refinery, France  
Application Date: October 2013

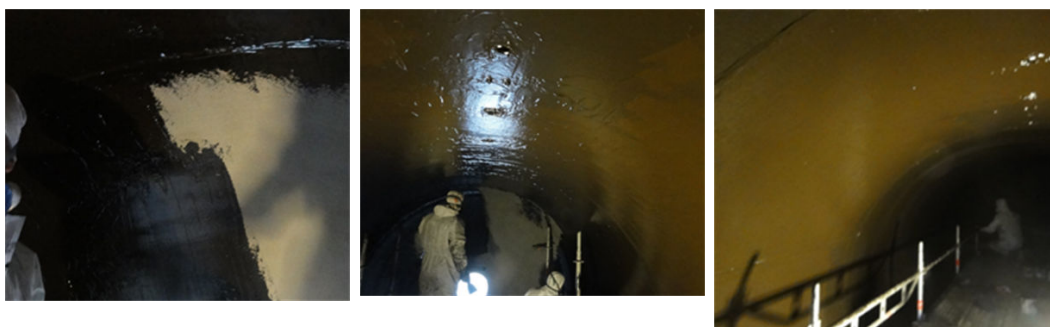
The pressurized equipment was subject to abrasion and regularly cleaned with high pressure. The temperature of the hydrocarbons was up to 150°C.

- \* Application on grit-blasted substrate ,
- \* Completing the application on the top part of the tank ,
- \* Inspecting the thickness of the coating ,

Buffer store with a diameter of 3m and length of 11m, transporting crude oil.

The application was carried out during a shutdown of the refinery. The entire application was completed in a one coat system.
