Belzona Refurbishes Drum Screen

Customer Location: Power station - UK
Application Date: May 2005

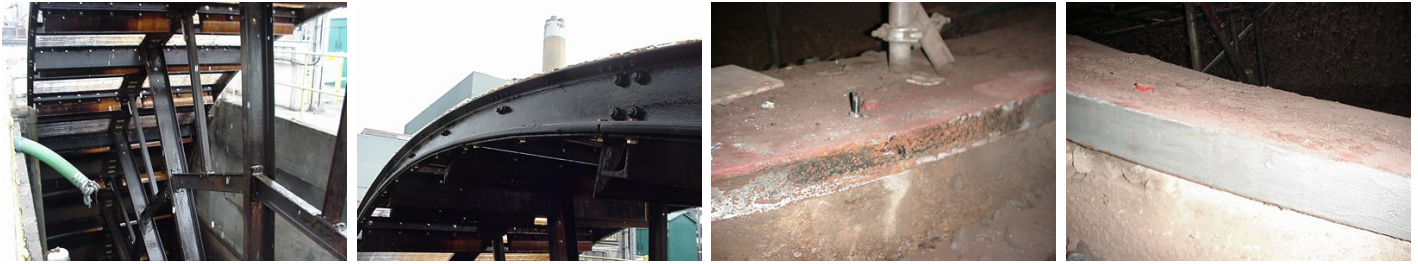
Photograph Descriptions

The rubber edge seal on the rotating screen wheel had, over many years, worn the steel mating edge in the chamber

- * General view of the drum screen ,
- * View of the rubber side seal ,
- * The eroded seal face ,
- * Seal face rebuilt with Belzona® 1311 ,

Application was carried out in accordance with a modified version of Belzona Know-How System Leaflet VPF-1. After thorough cleaning the profile was rebuilt with the Belzona® 1311.

Welding was being considered but this would have taken several weeks to complete as it would have involved removing the edge plates, welding and re-machining. The Belzona application was completed in-situ and in a fraction the time the welding option would have taken. Twenty-eight kilograms of Belzona® 1311 were used in the application.
