BELZONA REPAIRS DRIVE SHAFT ON ROLLING MILL

ID: 5510

Customer Location: *Steel Plant, Leningrad Region, Russia*
 Application Date: *June 1998 and September 2010*

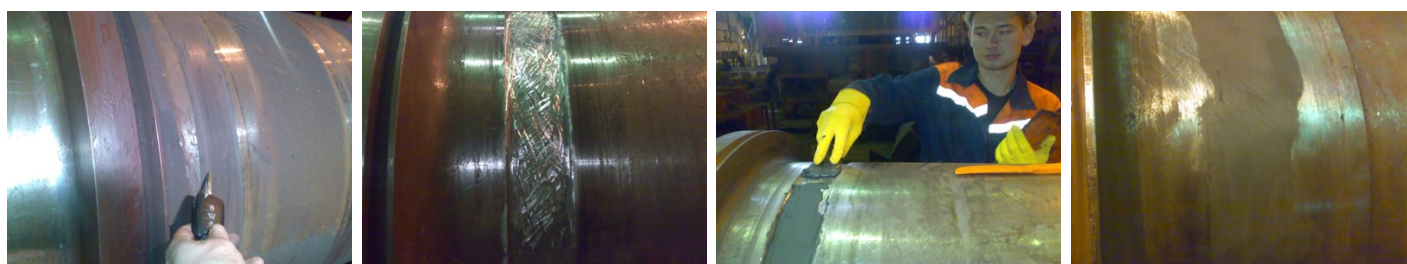
Photograph Descriptions

Deteriorated shaft in gasket seating areas (6 gaskets 50-90 m wide with a diameter of 709.25 mm on each shaft) causing excessive oil consumption. Original Belzona application lasted 12 years so the customer immediately turned to Belzona again.

- * Close-up view of the damaged shaft area ,
- * Prepared surface for the application of Belzona 1131 ,
- * Application of Belzona 1131 ,
- * Completed shaft repair ,

Deteriorated drive shaft on four high rolling mill.

The application was carried out in accordance with Belzona Know-How System Leaflet MPT-1.

The repair was carried out in-situ, minimizing transportation and downtime associated costs. The cost of the application was significantly lower compared to traditional repair methods such as overlay welding. The Belzona repair has proved to last for 12 years since the first application in 1998, therefore, when additional maintenance was required in 2010, Belzona was the first choice for the client.
