# BELZONA REPAIRS A SCREW PUMP

ID: 5513

**Industry:** Pulp & Paper  
**Application:** WPA-Wall Problem Areas  
**Substrate:** Concrete  
**Products:** \* Belzona 4111 (Magma-Quartz) ,  
\* Belzona 4911 (Magma TX Conditioner) ,  
\* Belzona 5811 (Immersion Grade) ,

**Customer Location:** Leningradsky District, Russia  
**Application Date:** October 2010

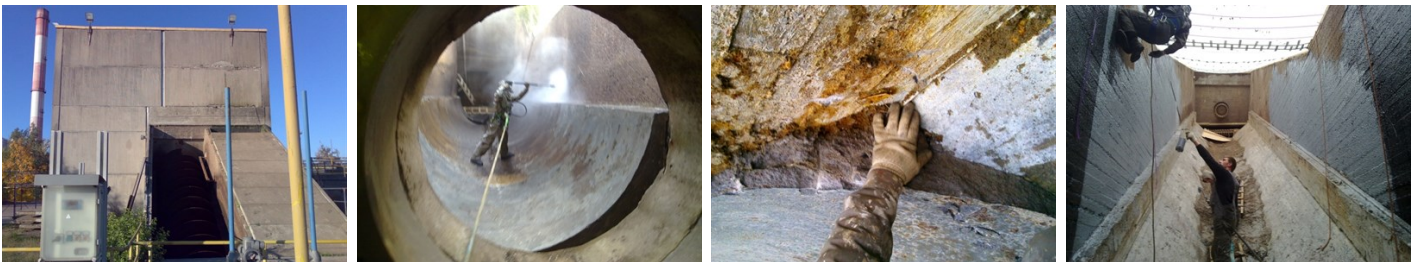
After more than 20 years in service, a 10 mm wide isolation joint between the gutter and screw extended to 20-30 mm due to concrete wearing out, which has led to a significant efficiency loss of the pump.

- \* General view of two screw pumps ,
- \* Cleaning of the gutter using high pressure equipment in progress ,
- \* The depth of the applied material shown ,
- \* Application of Belzona 5811 ,

Gutter walls and sump were cleaned using high pressure equipment. Old concrete was removed from the gutter using a pneumatic tool. After the surface preparation, Belzona 4111 was applied on the gutter to restore the geometry of the surface. Belzona barrier coating was then applied on the gutter walls to provide chemical resistance.
