BELZONA FLANGE FACE FORMING ON 4" 150psi FLANGES

ID: 5516

Customer Location: Oil Major, North Sea, UK
Application Date: November 2014

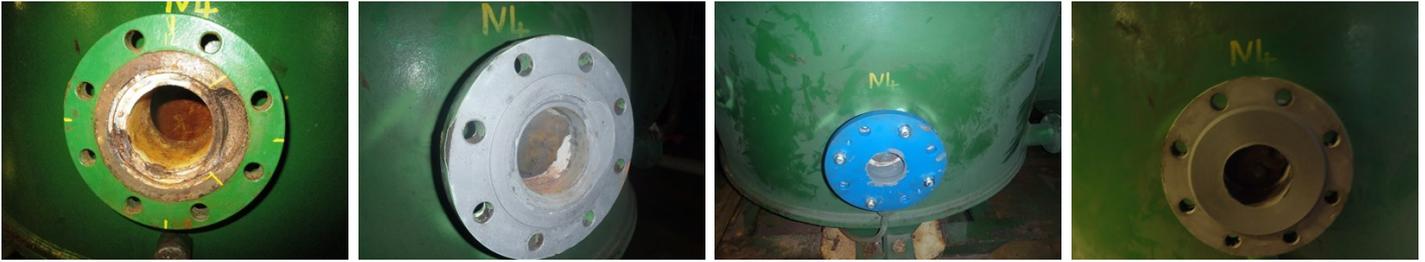
Photograph Descriptions

Existing coating had failed leading to corrosion of the vessel internals and severe loss of metal on the adjacent flanges.

* 1. Damaged flange face 2. Flange face after grit blasting and deep pitting roughly infilled with Belzona 1111 3. Belzona flange former in place 4. Completed application after removing former ,

Application was carried out in accordance with Belzona Know-How System Leaflet VPF-17 using the Belzona flange face forming kit.

Client was unable to use hot work and had restricted time. Application was carried out over a weekend and the entire solution, from first notification was completed in less than a week. A number of flanges were reformed using the Belzona re-usable formers. The vessel was returned to service with minimum disruption to the production cycle.
