BELZONA PROTECTS NEW STAINLESS STEEL PIPE SPOOLS

ID: 5526

Customer Location: Gas Fired Power Station, Avonmouth, UK
Application Date: December 2014

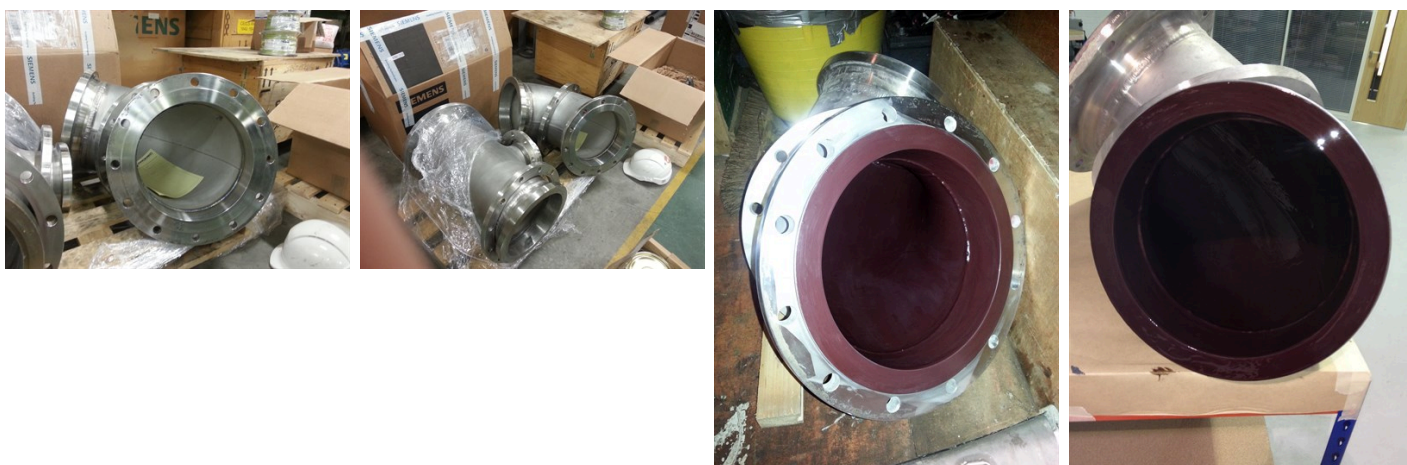
Photograph Descriptions

- * New pipe spools before coating ,
- * New pipe spools before coating ,
- * Pipe spools after coating ,
- * Pipe spools after coating ,

The Power Station had 2 newly fabricated stainless steel pipe spools which were required to have an internal protective coating.

The application was carried out in accordance with Belzona Know-How System Leaflet VPF-2. After masking off all areas not to be coated, all edges were radiused and welds ground smooth before being grit blasted and coated with the Belzona 4311 system.
