BELZONA PROTECTS TOOTHPASTE FACTORY FLOOR

ID: 5530

Application: FPA-Floor Problem Areas

Substrate: Steel Chequer Plate

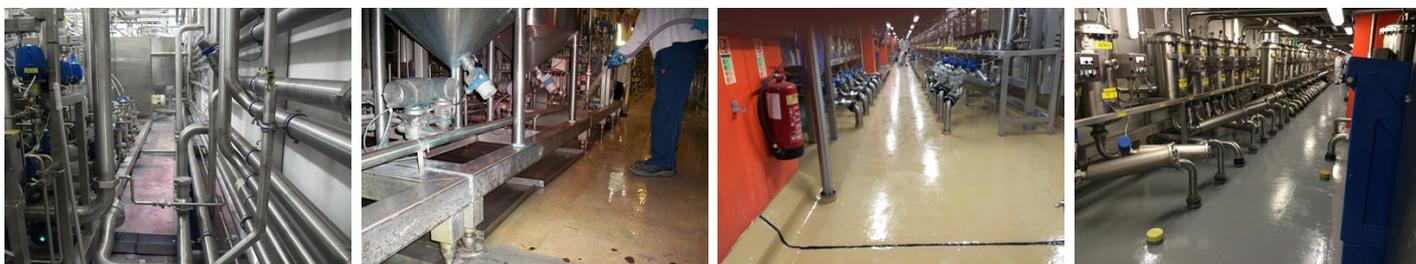
Photograph Descriptions

The originally applied protective coating on the floor had failed, due to the spillage of Flavour Oils and the use of caustic soda to clean the room daily. As a result, water/cleaning fluid was leaking through the floor and into the packing area below. The existing polyurethane coating was in most part still intact and showed good adhesion to the steel/aluminum chequer plate. The area's which have failed are where the floor is most exposed to the chemicals i.e. drain areas and flow paths. Access to some of the areas was restricted by pipe work and plant.

- * Damaged Floor ,
- * Washing to remove dye ,
- * 1st coat application ,
- * 2nd coat application ,

The application was carried out in accordance with Belzona Know How System Leaflet FPA-3. All sound areas of the existing coating were left in place as total removal was not an option.

Prior to the application, a trial area of 50m² was applied with the Belzona system. Thoroughly satisfied with the result, the customer

proceeded with the application to the complete 2000m² area.
