BELZONA REPAIRS PILLARS OF A RAILROAD TRACK

ID: 5534

Customer Location: Steel Industry, Pará, Brasil
Application Date: April 2012

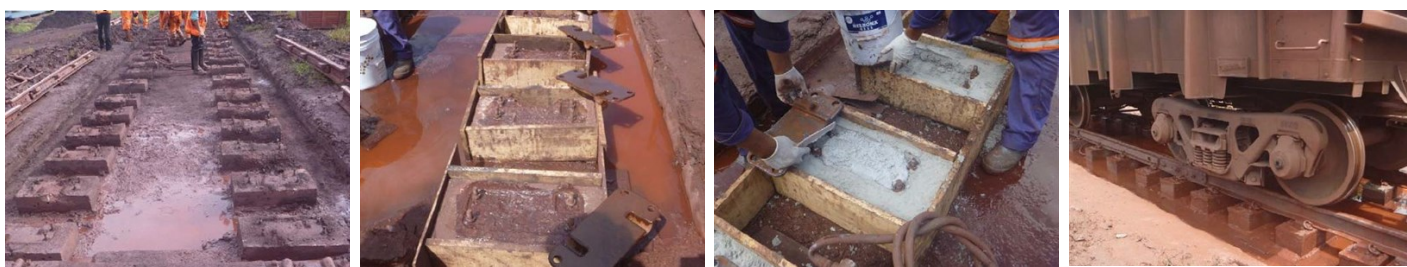
Photograph Descriptions

The area of the 48 deteriorated pillars negatively influence the operation of the railway.

- * General view of the damaged pillars ,
- * Installation of the forms to the pillars after cleaning ,
- * Application of Belzona 4111 ,
- * Wagons operating on the repaired pillars ,

The pillars were first cleaned with a water jet and steel brush. The leveling of the pillars was carried out with the assistance of a topography tool and then Belzona 4111 and Belzona 4151 were applied. The application was carried out in accordance with Belzona Know-How System Leaflet TCC-9 and FPA-1.

4 hours after the application of Belzona, the tracks were installed, and 8 hours after the application, the cargo train was released for operation. Upon completion of the application with Belzona Technology, the railway was cleared for operation within little time.
