BELZONA PROTECTS NEW BUILD DESALTER

ID: 5540

Customer Location: Refinery, UK

Application: TCC-Tanks and Chemical Containment Areas

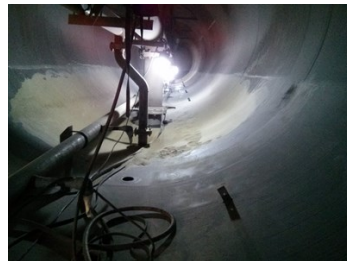
Substrate fully grit blasted.

Application was carried out in accordance with Belzona Know-How System Leaflet TCC-5. Belzona 1591 applied to the bottom third of the vessel.

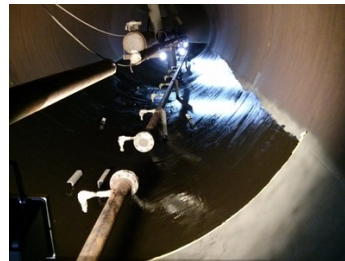
Finished application.

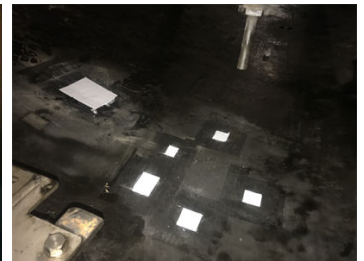
Remedials in November 2020 with Belzona 1593.

The sheer size of the vessel (35.6 m (117 ft) long x 3.6 m (11'9") ID) required a dedicated team from Belzona to train and validate the application contractor, provide field support with a coating inspector and a bilingual project supervisor. The lining project was successfully completed in March 2014 to the required specification and schedule agreed with the client. In the future such projects will be completed with Belzona 1593, which offers significant benefits in application ease. In November 2020, the vessel was inspected by engineers and the coating was found to be in excellent condition apart from some small defects to the top coat. A small number of remedial repairs were undertaken which amounted to 4 units of Belzona 1593 and the vessel was put back into service until the next inspection interval in 6 years.
