BELZONA PROVIDES LONG TERM PROTECTION FOR ION EXCHANGE VESSEL

ID: 5552

Customer Location: *Uranium Mine, Malawi*
Application Date: *April 2011*

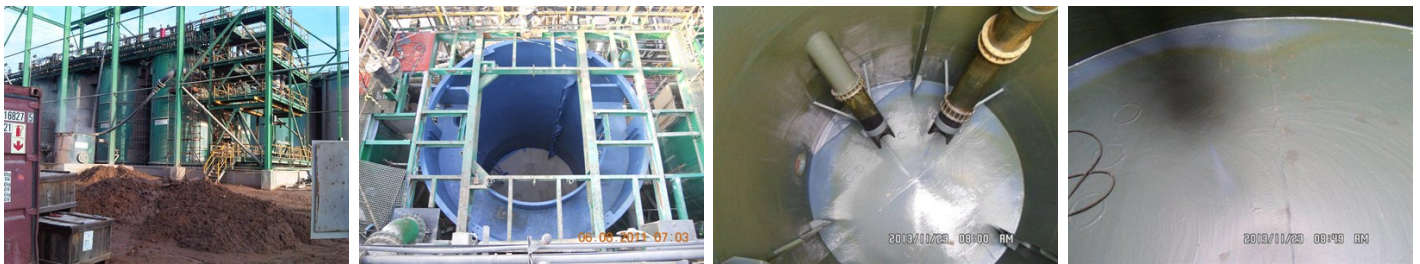
Photograph Descriptions

An existing glassflake lining suffered regular localized damage.

- * External view of Resin in Pulp tank. ,
- * Completed application of Belzona 1321 in 2011. ,
- * Inspection in 2013. Lining has stained from the process but is in perfect condition. ,
- * Close view of the base of the tank where the most wear occurs. Lining in excellent condition. ,

The customer decided in 2011 to replace the failing glassflake lining entirely with Belzona 1321. The application was carried out in accordance with Belzona Know-How System Leaflet TCC-3. Following surface preparation to the required standards, all internal surfaces were lined with three coats of Belzona 1321 for additional erosion protection. Following lining, the application was thoroughly inspected prior to return to service.

Following repeated failure and disbondment of the original glassflake lining, the customer sought an alternative lining and selected Belzona 1321 based on its superior erosion resistance and performance in immersion.
