# BELZONA LINING OF AROMATIC RECOVERY SEPARATOR

Industry: Oil & Gas  
Application: TCC-Tanks and Chemical Containment Areas  
Substrate: Steel  
Products: \* Belzona 1331 ,

Customer Location: Oil and Gas Industry, North Sea, UK  
Application Date: January 2015

An aromatic recovery separator on an offshore UK production platform

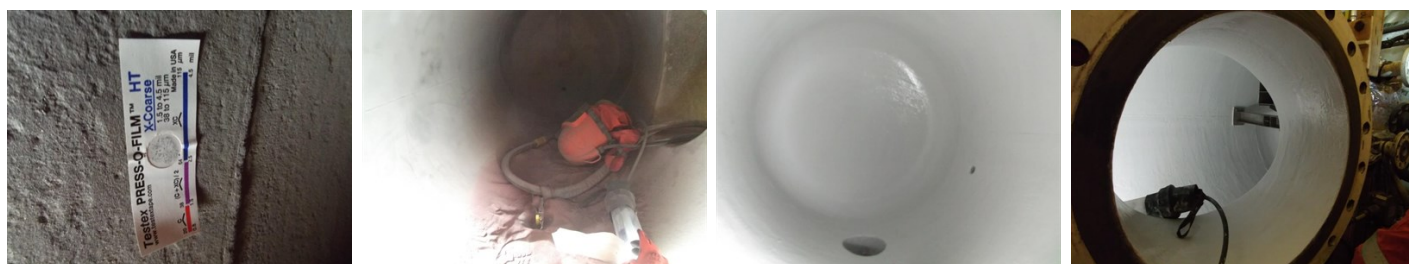
*The internal surfaces had suffered from general corrosion and pitting, requiring protection to ensure continued service.*

- \* Condition of the substrate following surface preparation ,
- \* Completion of the surface preparation ,
- \* Belzona 1331 applied to internal vessel surfaces ,
- \* Completed lining terminating at the manway entrance ,

Belzona 1331 was applied in accordance with Belzona Know-How System Leaflet TCC-3. Following thorough surface preparation, Belzona 1331 was brush applied in two coats to ensure complete surface coverage. After sufficient cure, the lining was inspected before returning to service.
