# BELZONA GRIP SYSTEM FOR ELECTRIC DRIVE ROLLER

*The rubber cladding on the exterior of the drive roller had failed and delaminated.*

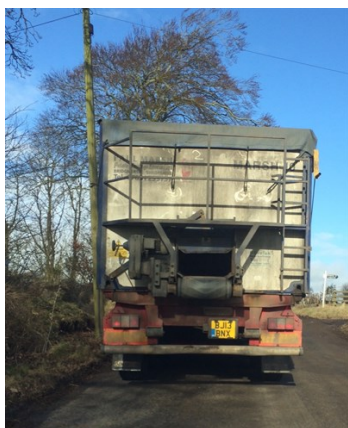
- \* Drive roller on lorry ,
- \* Drive roller prepared ,
- \* Application of Belzona 1321 ,
- \* Completed application of grip system ,

The application was carried out in accordance with Belzona Know-How System Leaflet SHM-12. Belzona 1321 was applied using a stiff bristle brush and the aggregate was then sprinkled onto the wet coating to blind the surface. The aggregate was then tamped in and the application was left to cure.
