WATER REPELLENT BELZONA TREATMENT FOR SWIMMING POOL WALLS

Customer Location: *Local Council Swimming Pool,
Gloucestershire, UK*

Application: *WPA-Wall Problem Areas*

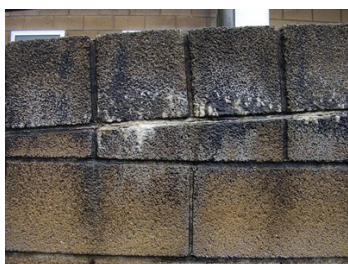
Water penetration into the building fascia was causing salt to be washed out of the bricks, visibly discolouring the wall and leaving the swimming pool looking worn and tired.

- * Concrete blocks stained with salt ,
- * Repair area lightly blasted ,
- * Application of Belzona 5122 ,
- * Application revisited after 7 years in service ,

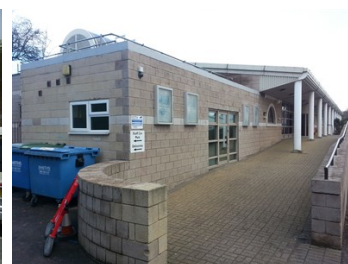
work. Blasting was carried out before opening hours and the water repellent treatment was carried out in 2 stages to ensure minimum disruption to the public. The system has lasted the test of time for the council and they are more than happy with the results. No salts or staining on the concrete block walls is visible even after 7 years.
